State of Wisconsin/Department of Transportation
RESEARCH PROGRESS REPORT FOR THE QUARTER ENDING: June 30, 2007

Program: SPR-0010(36) FFY99		Part: II Research and Development	
Project Title: Evaluation of Methods of Rebar Protection, Prevention, and Repair Techniques on Concrete Girders		Project ID: 0092-06-06	
Administrative Contact: Nikki Hatch		Sponsor: Wisconsin Department of Transportation	
WisDOT Technical Contact:		Approved Starting Date:	
Approved by COR/Steering Committee:		Original End Date:	
Project Investigator (agency & contact): H. Tabatabai, UW-Milwaukee		Current End Date:	
		Number of Extensions:

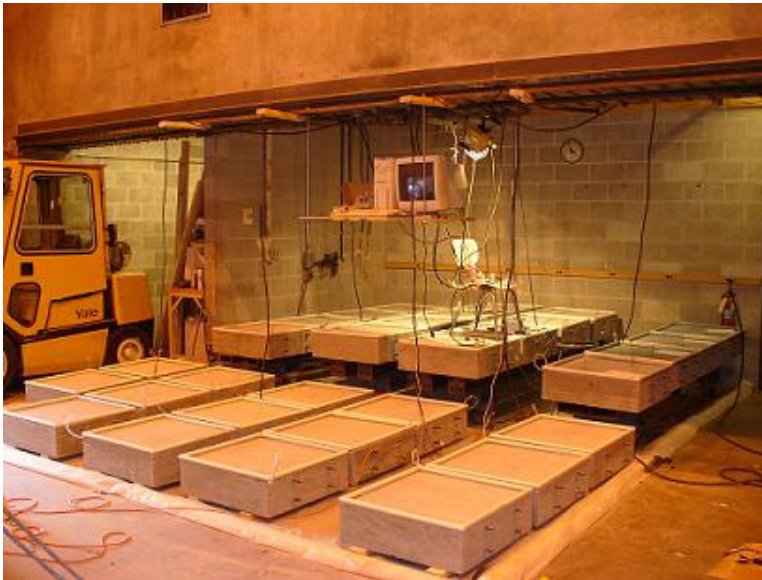
Two bridges in Dodge County were visited and chloride samples were taken. Zinc spraying on specimens was completed. All specimens were placed in position and wiring was completed. Test specimens are shown below:
